PEUGEOT 205 GTI

HISTORY

SPECIFICATION

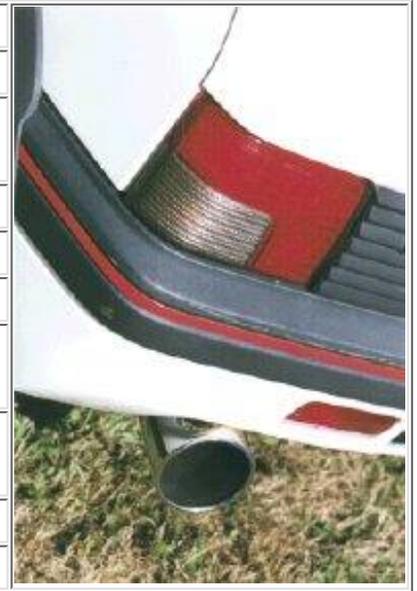
(1.6 model - 91')

badge	205 GTI 1.6
model code	20CB62
engine	XU5JA 1,580 cc in line four cylinders, 8 valves
max. power	115 hp (83 kW) at 6,250 rpm
max. torque	96.62 lb ft at 4,000 rpm
gearbox	5 speed manual (BE 3/5)
brakes	front : ventilated discs rear : drums
tires	185/60 HR 14 (originally) 195/50 VR 15 (now)
overall fuel consumption	28.3 mpg
kerb weight	850 kg

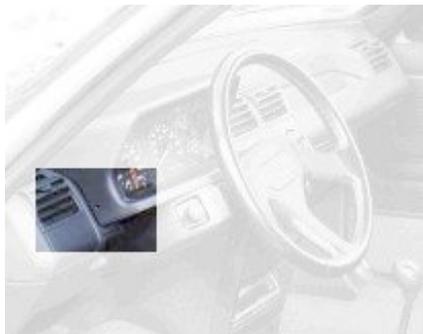
The instrument panel should not present any trace of disassembling. When holding firmly the instrument panel, it should not shake. Check the torx screw by the small hole at the left of the instrument cluster : if the screw is missing or has been replaced by another kind of screw, the instrument cluster has been removed and not well put back.

Try to locate any fingerprint into the instrument cluster.

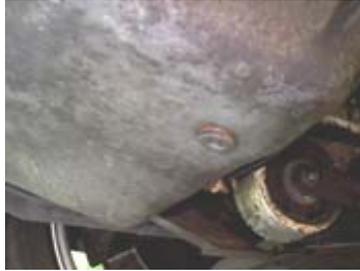
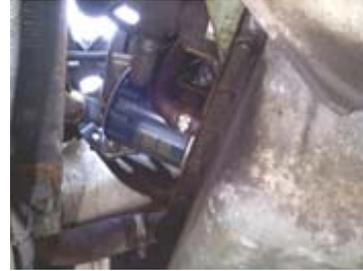
Engine oil change + filter

A 8 mm square wrench will be necessary as well as an oil filter wrench. The oil filter is located in front of the engine, between the engine and the radiator.

Use semi-synthetic oil or 100% synthetic oil. Change oil every 3,100 mi or max 4,600 mi.

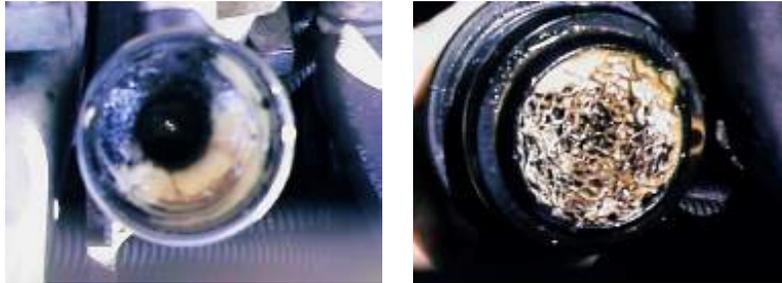
Mayonnaise in oil filler cap : it's mostly due to short trips. Clean oil filler cap at each oil drain. After high mileage, remove grill in oil filler cap and clean with solvent.

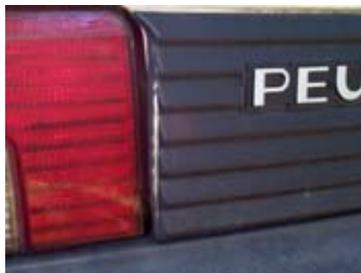
Broken tailgate panel : Side of the tailgate panel are prone to break.
